# **Pre-Demolition Hazardous Building Materials Inspection Report**

Ramada (former Thunderbird) Hotel  
2300 East American Blvd.  
Bloomington, Minnesota

Project B1604822  
June 30, 2016

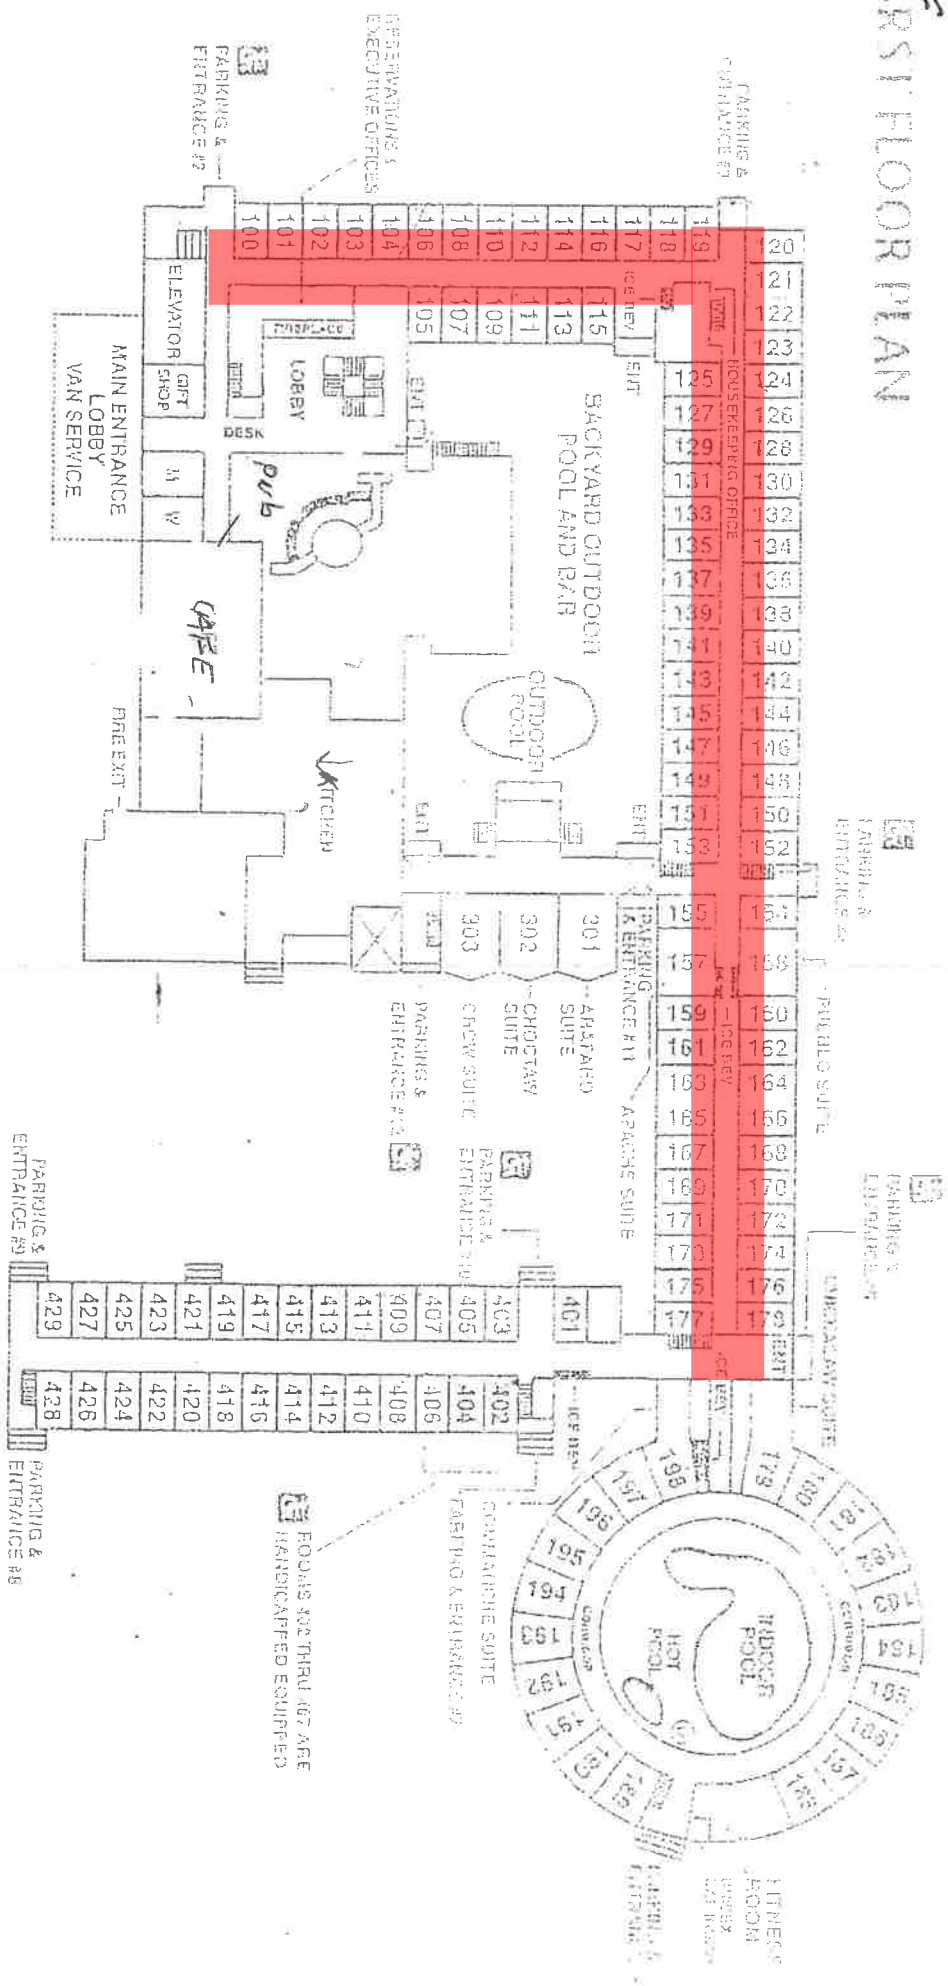
# 1<sup>ST</sup> FLOOR PLAN

Identified Spray-applied ACM Fireproofing
